Property Inspection Report by A-TEX Home Inspection

Concerning: Sample Trail, Texas 78660 DATE: 6/2/2014 Inspection time : 1 pm	
REPORT FOR CLIENT: xxxxxx	INVOICE: NO/xxxxxxxxxxx
	DESCRIPTION AND FEES: Phase II frame Inspection:
	TOTAL: Thank you for your business DATE: 6/2/2014

Building Status: Phase II – Frame inspection

STRUCTURE TYPE: RESIDENTIAL 1 story

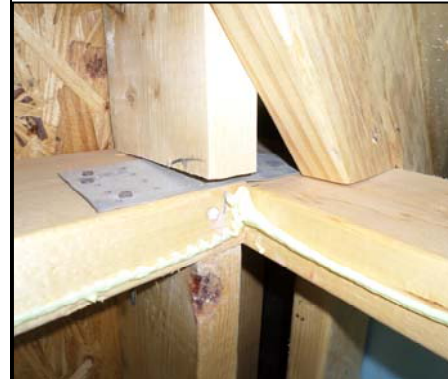
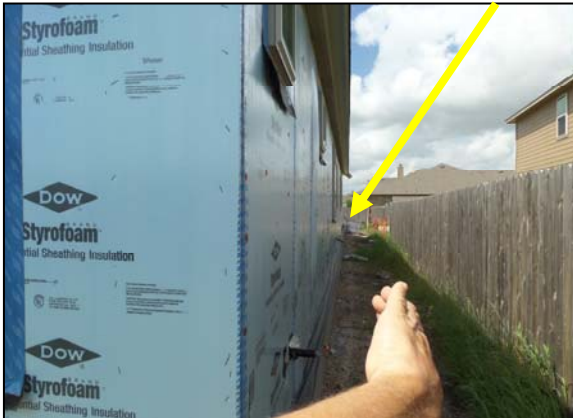
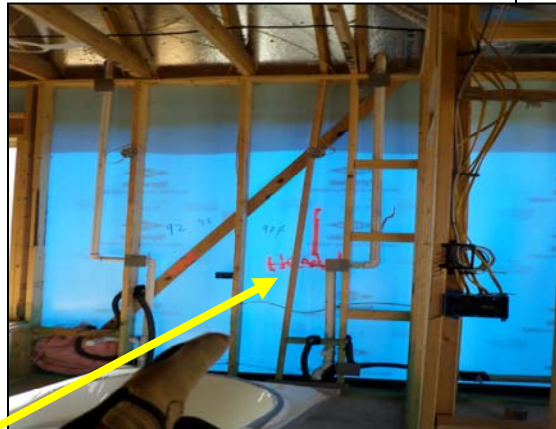
Several Foam boards at the left side are warped. Recommend to verify on the building plans if only Foam board installation is specified.

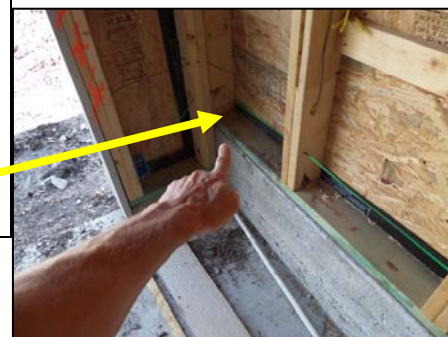
1 wall stud at master bath substandard installed (of center) to accommodate the plumbing. Evaluate and correct this installation or add additional stud

Wall frame; sill plates anchored to the foundation with proper anchor bolts & spacing. 1 bolt not located 12 inches from the garage end plate section or was covered by wall stud. Recommend to install or evaluate further with contractor/ builder.

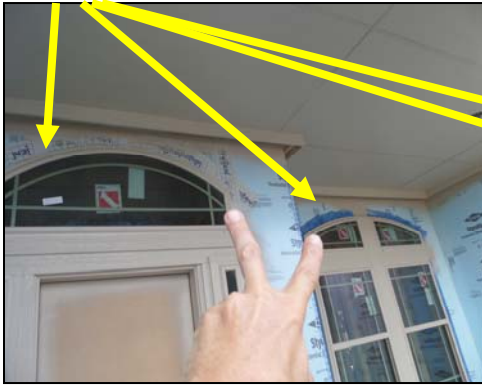
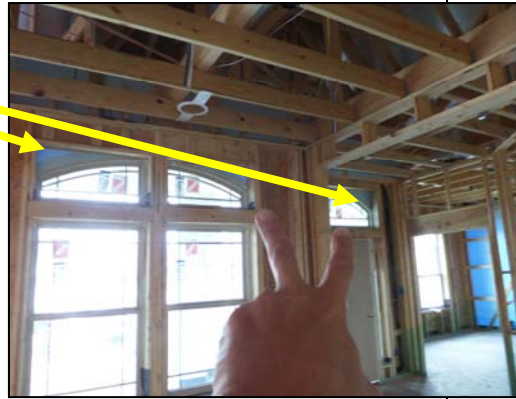
3 arc Window at the front entrance enclosure, upper arc sections was not framed in, only foam board panels installed. This should be repaired. Verify if specified on the building plans. **No plans provided at the time.**

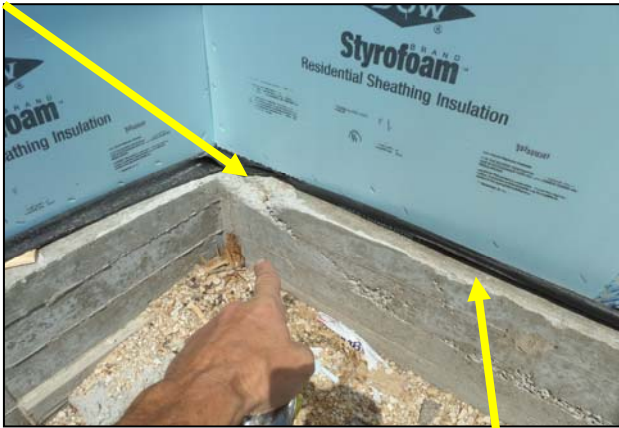
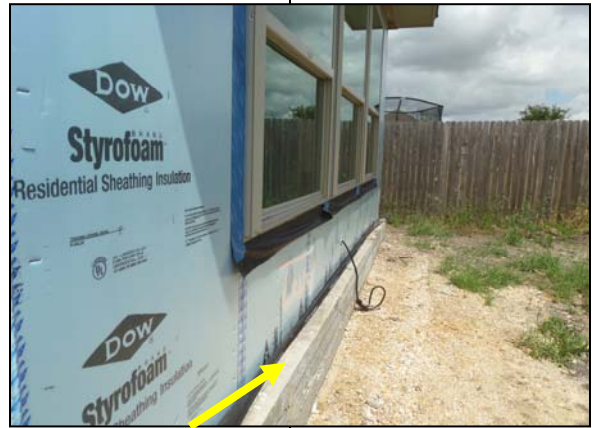
Minor foundation surface damage to the rear brick ledge from early removal of prior form boards. Concrete repair is recommended prior to brick veneer wall installation and paring.

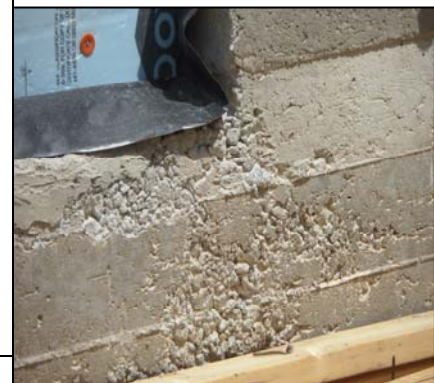
Foundation: Brick ledge flashing is installed, several membrane sections should be proper placed before brick wall installation. Brick walls will be inspected toward the end of construction.

Minor aggregate showing from improper mix at several foundation sections. Cosmetic. **Pariging will be installed and inspected toward the end of construction.**

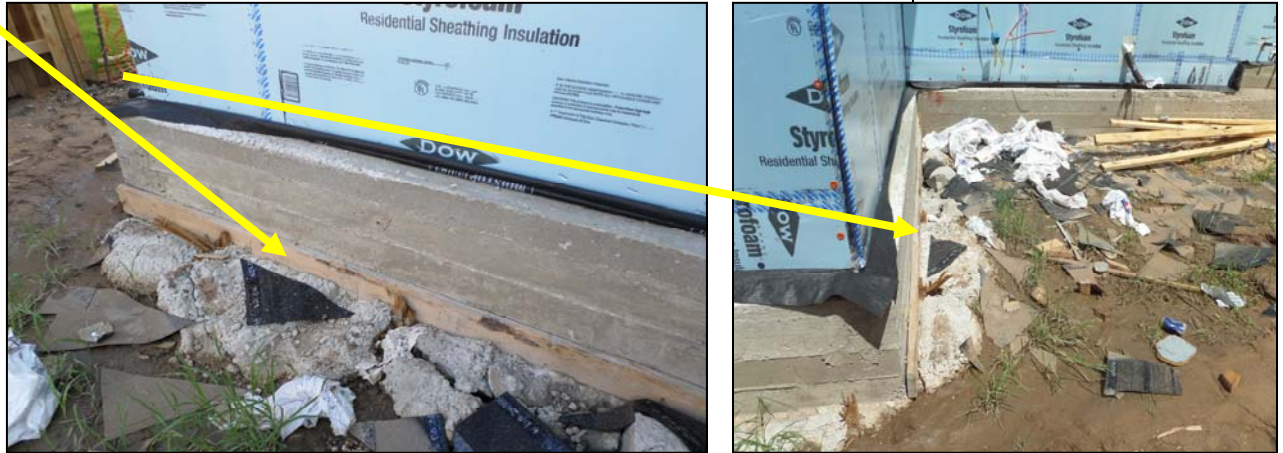
Final grading will not be completed toward the end of construction; Roofing material and other debris should be removed prior to grading. Several Form boards & stakes should be removed prior to grading. Wood left in soil is conducive to WD insects.

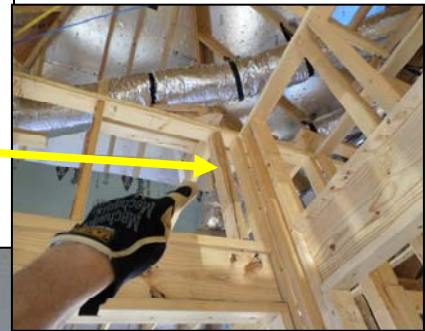
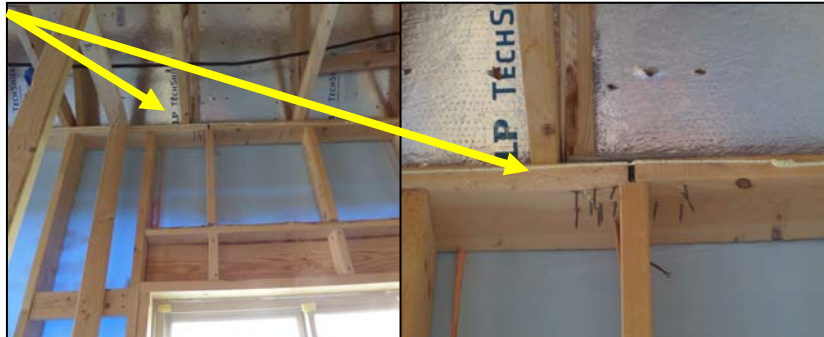
1 Cripple wall stud damaged (splits) below purlins struts over door frame in master bath. Recommend replacing or add additional short stud.

1 Cripple wall stud not centered over 1 rafter by more than 1". Recommend adding additional short stud.

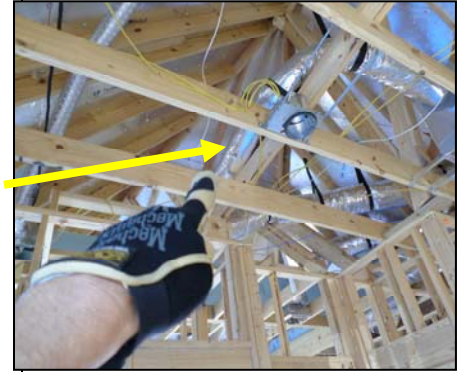
R-rated ducts; all connections proper strapped & sealed with full mastic. Duct; frap section at the hall way is minor damaged, seal/repair section to prevent further damage.

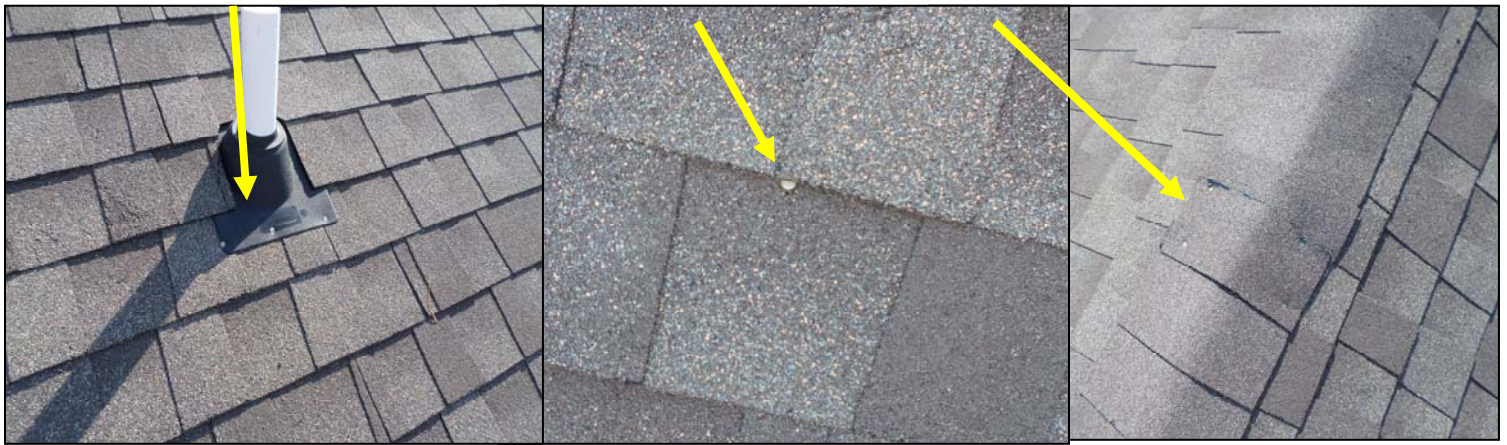
INFO: Roofing nails not sealed at ridge shingles, Flue vent flashing, pot vents and plumbing vents.

Seal to prevent seepage. Components will be inspected during the final inspection.

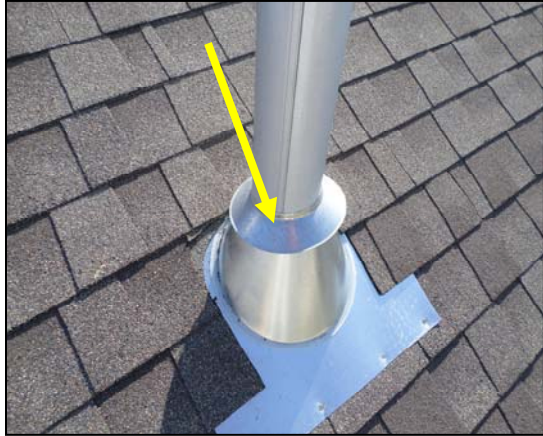
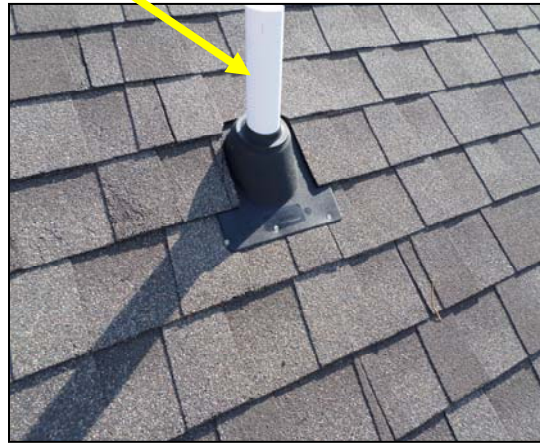
Flue vent collar not sealed and plumbing vents are not yet painted. Components will be further inspected during the final inspection.
