Property Inspection Report by A-TEX Home Inspection

Concerning: Sample Trail, Texas 78660 DATE: 6/2/2014 Inspection time : 1 pm	
REPORT FOR CLIENT: xxxxxx	INVOICE: NO/xxxxxxxxxxx
	DESCRIPTION AND FEES: Phase II frame Inspection:
	TOTAL: Thank you for your business DATE: 6/2/2014

Building Status: Phase II – Frame inspection

STRUCTURE TYPE: RESIDENTIAL 1 story

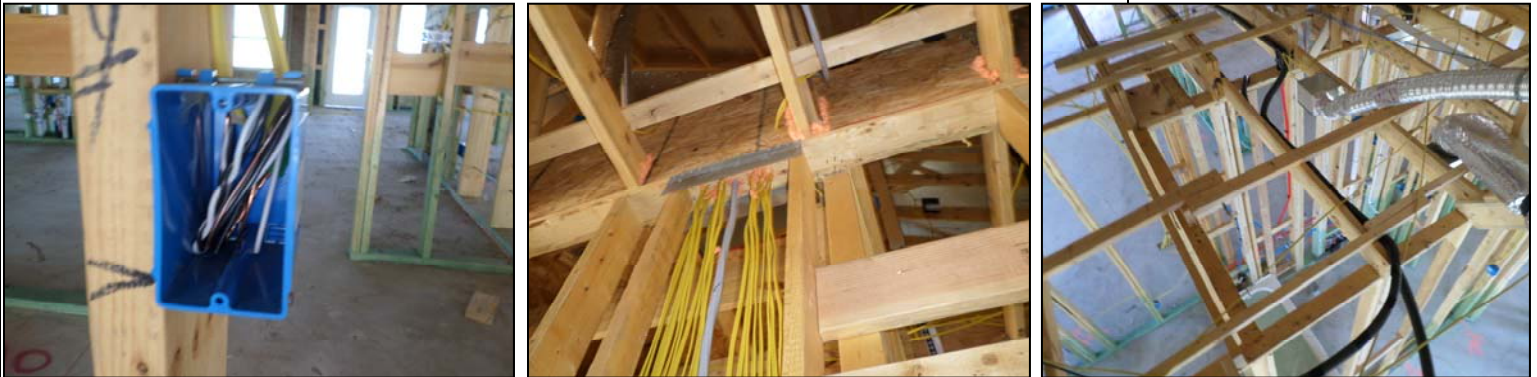
Openings trough exterior stud walls around electrical, cable penetration and plumbing were proper insulated & sealed as necessary. Proper fastener installed to prevent movement to plumbing.

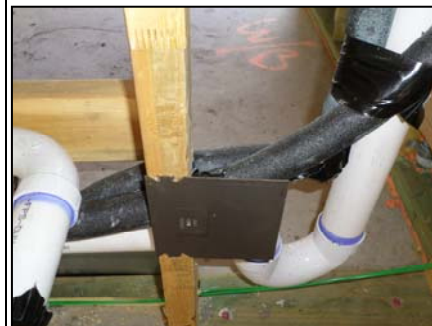
Openings trough interior stud walls around electrical, cable penetration and plumbing were proper insulated & sealed as necessary. Draft stop and **nail** plates installed. Proper fastener installed to prevent movement to plumbing.

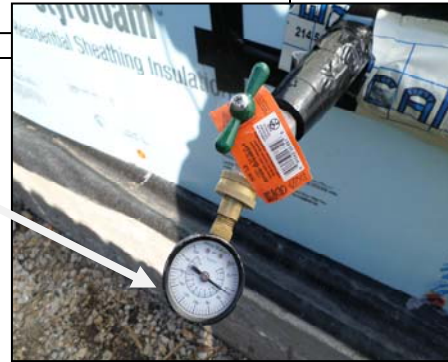
Static water pressure reading: (42) PSI. Safe to fittings or other equipment between 40 to 80 PSI.
No signs of water leaks on water supply lines were visible at the time of inspection

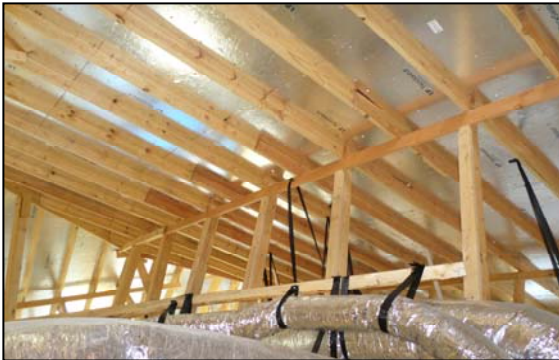
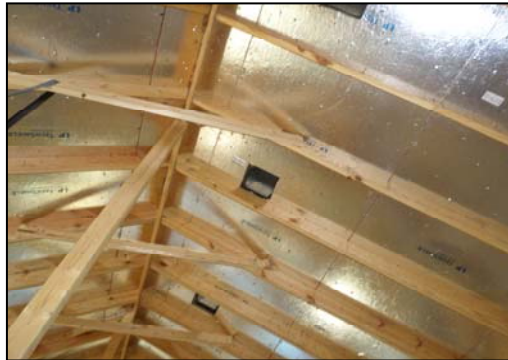
Roof Framing:
Type: Conventional. **24 inch spacing.** Purlins, struts/strong back used as support and Rafter ties installed as required.

1 Cripple wall stud damaged (splits) below purlins struts over door frame in master bath. Recommend replacing or add additional short stud.

1 Cripple wall stud not centered over 1 rafter by more than 1". Recommend adding additional short stud.
